Former St. Cyres School Site, Dinas Powys

Arboricultural Impact Assessment

Our Ref: JSL2735_775B

Prepared by:	Chris Chambers
Authorised by:	David Cox
Date:	August 2017
Project Number/Document Reference:	JSL2735_775B
Status:	For Planning

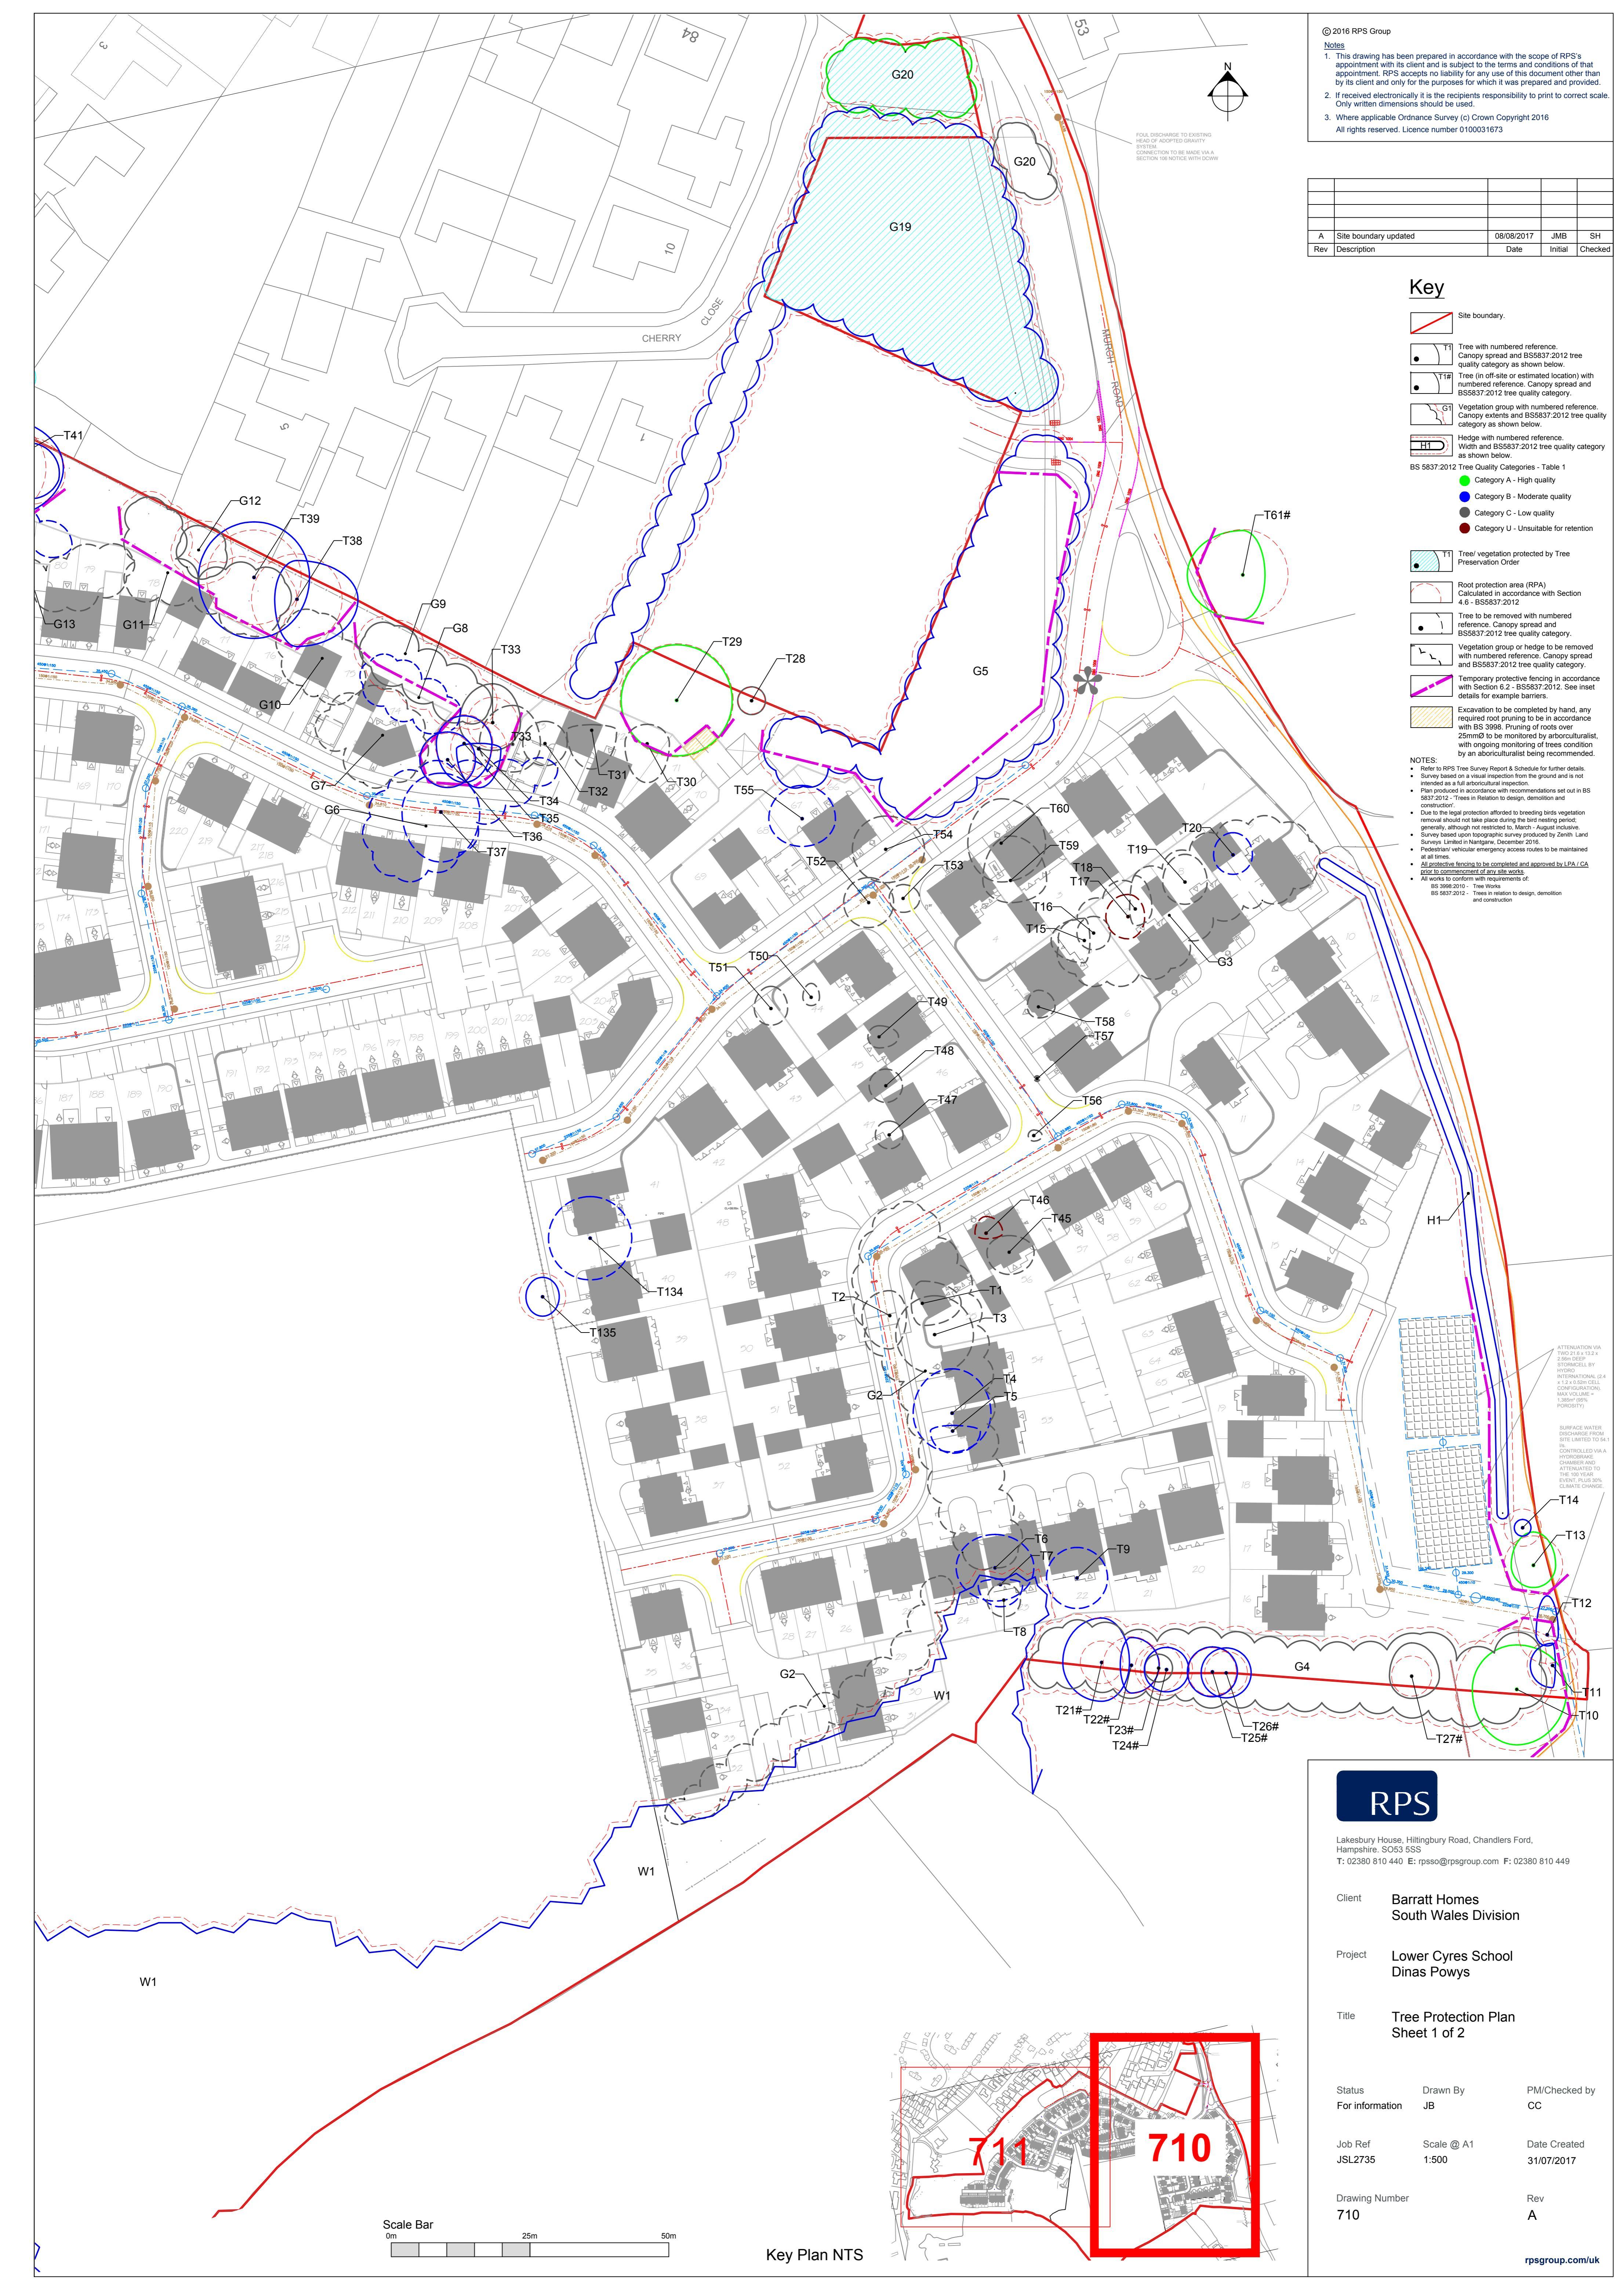
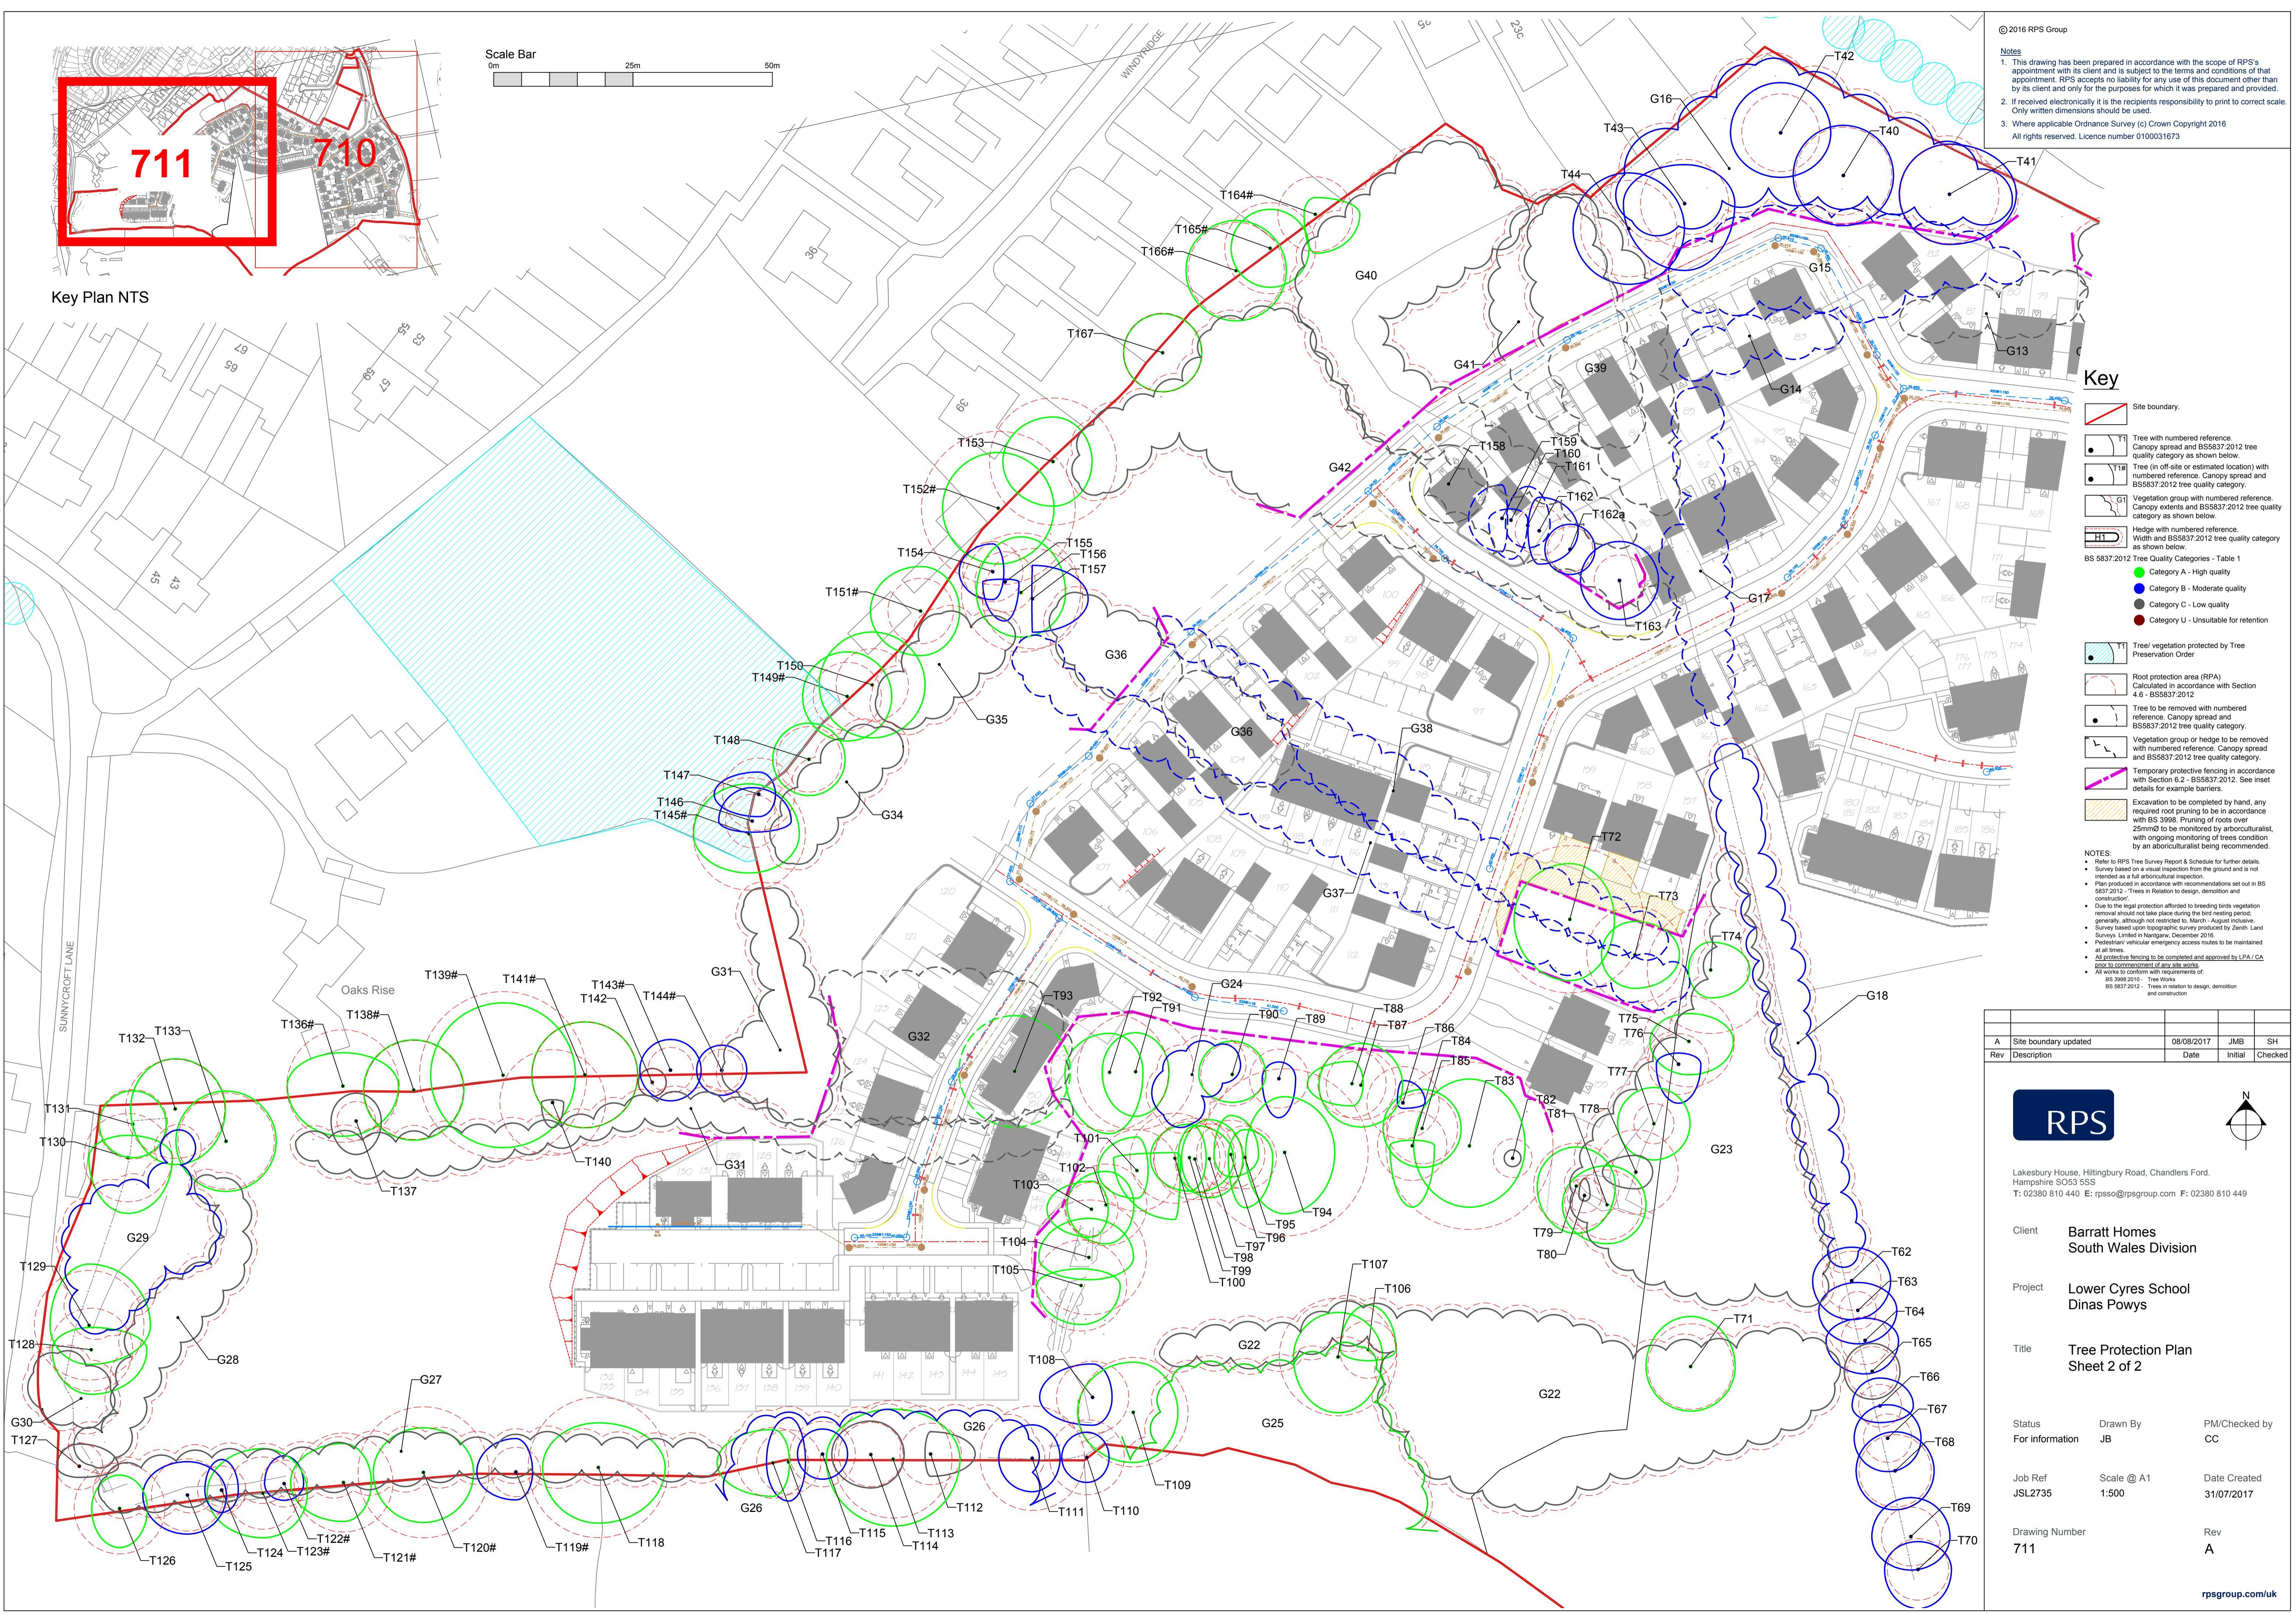
Tree Protection Plans JSL2735_710A & 711A

- 1.5 The Tree Protection Plans JSL2735_710 and 711 identify the following:
 - Trees to be retained;
 - Trees requiring removal;
 - Alignment and design of protective fence;
