SURVEY REPORT

MAPPING EXISTING BURIED SERVICES

BAYFIELDS CHEPSTOW

BARRATT HOMES

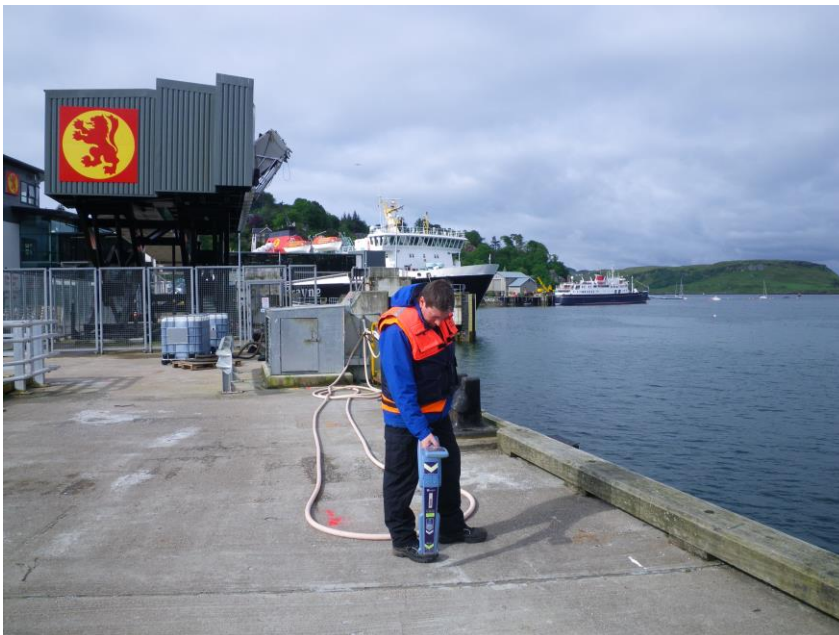
Fig. 2 Electromagnetic Scanning

The scanning equipment used was *Radio-Detection's RD 8000* precision locators and *RD 8000* transmitters, and accessories. A wide range of frequencies were available to suit all target types.

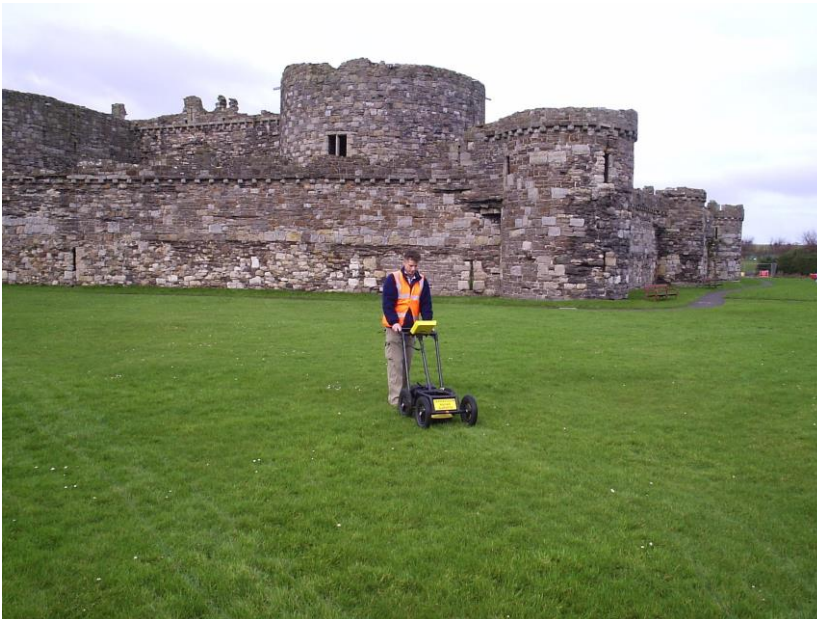
Fig. 4 GPR Surveying

A *Sensors & Software* radar system with a shielded 500MHz antenna (bandwidth 250 – 750MHz) was used in an on-site locating capacity to search the survey area for signal anomalies. Anomalies forming linear features were marked on site and added to the survey drawing.

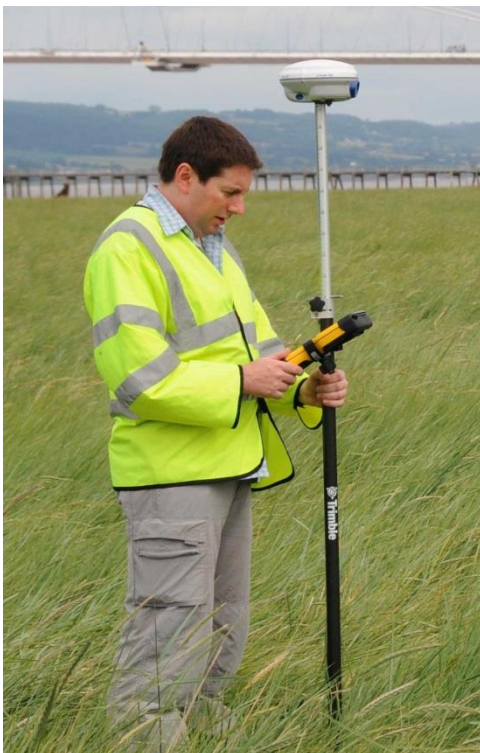
Fig. 5 RTK GNSS Surveying

Service routes detected during our investigations have been marked in paint on site. These ground markings have been surveyed using a *Trimble* RTK GNSS system. The Ordnance Survey scale factor has been removed from our results to transform the data to scale factor 1 (level plane) which has then been overlaid onto the client provided topographic survey in dwg format.

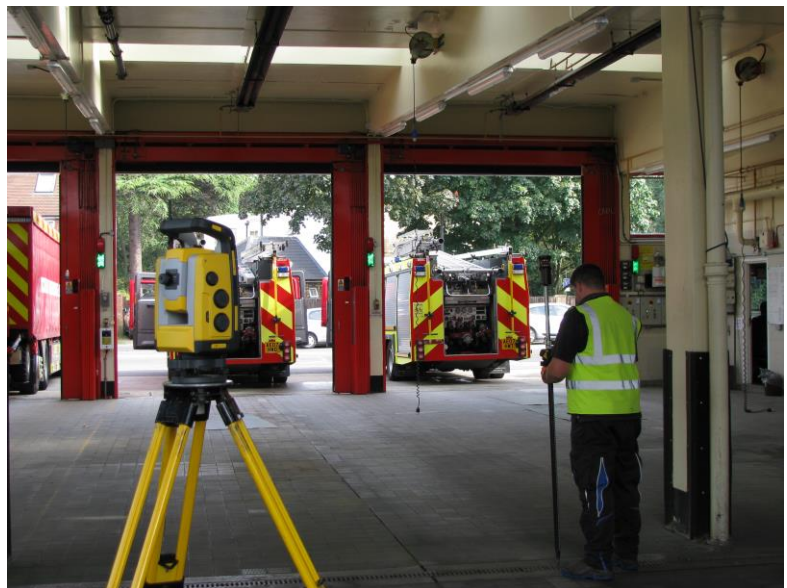
Fig. 6 EDM Surveying

Drainage invert depths have been measured from the surface using Laser EDM. All detail and measurements have been gauged from the surface whilst the system was operational and in flow and should not be considered as being absolute.
